Characterization of AlSi and AlSi-TiSi₂ Metal-Semiconductor Contacts

Mark Davis, Advisor: Dr. Michael Jackson

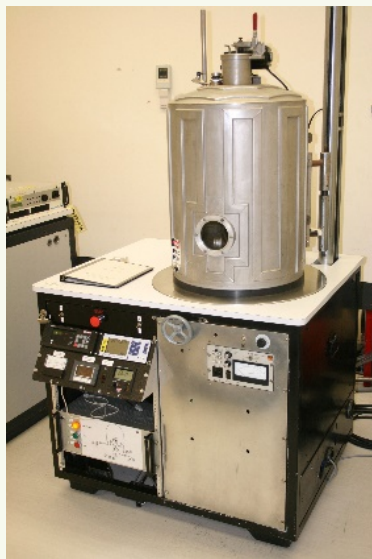
Figure 4. CVC Flash Evaporator. [4]
Aluminum Defect Observed

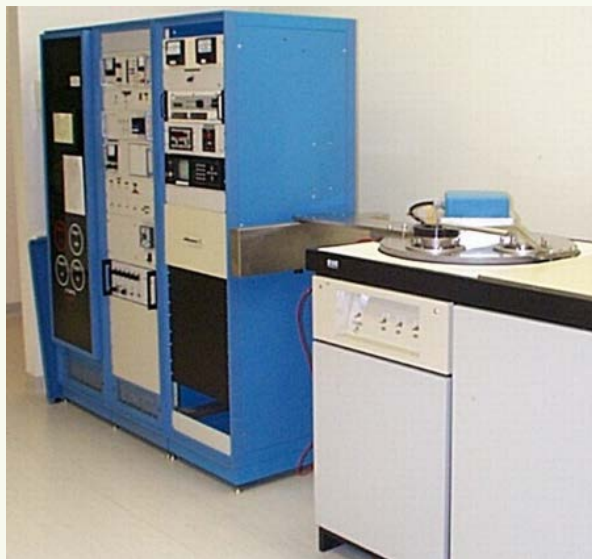
Figure 5. CVC601 DC Sputter. [4]
High Bulk Resistivity Measurements

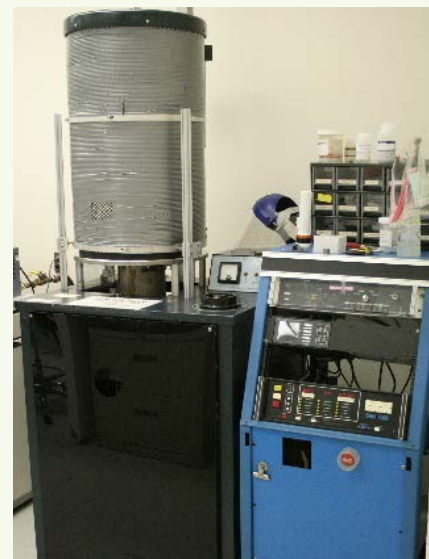
Figure 6. CHA Thermal Evaporator. [4]
Used as a Control

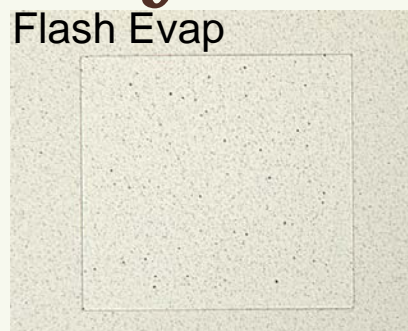
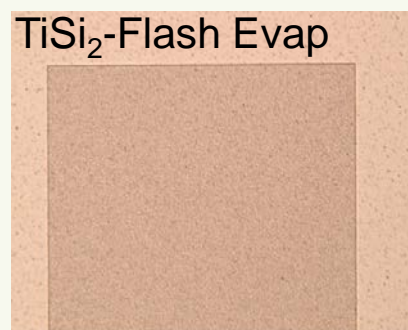
- The Spotted film defect appeared in all films, not just the Flash Evaporator film as hypothesized
- The defect manifested above Si, SiO₂, and TiSi₂

Figure 23. 10x Microscope Images of Sintered Films
