# **Water Breakthrough Behavior and GDL Degradation Mechanisms in a PEM Fuel Cell**

A Thesis Submitted in Partial Fulfillment of the Requirement  
for Master of Science in Mechanical Engineering

Rochester Institute of Technology  
New York 14623  
May, 2012

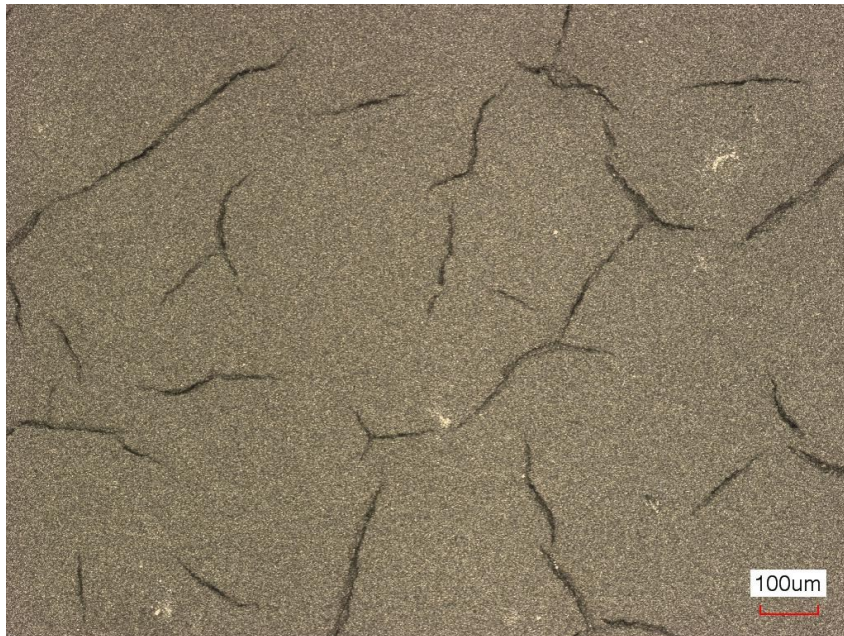
*Figure 3: CLSM image of the MPL (SGL Group Sigracet® 25BC).*

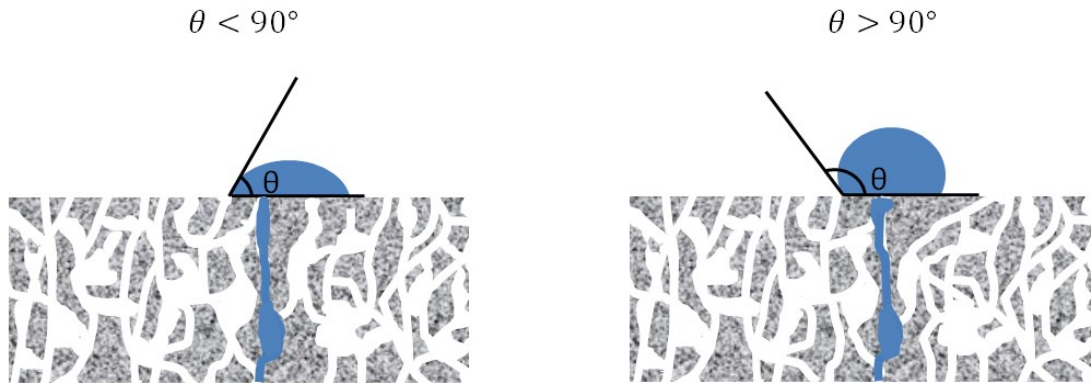
*Figure 4: Water emergence from a GDL with a hydrophobic surface (right) and a hydrophilic surface (left) (Reproduced from [3]).*

surface [1]. Figure 4 shows a water droplet emerging from a hydrophobic GDL on the right and a water droplet emerging from a hydrophilic GDL on the left.

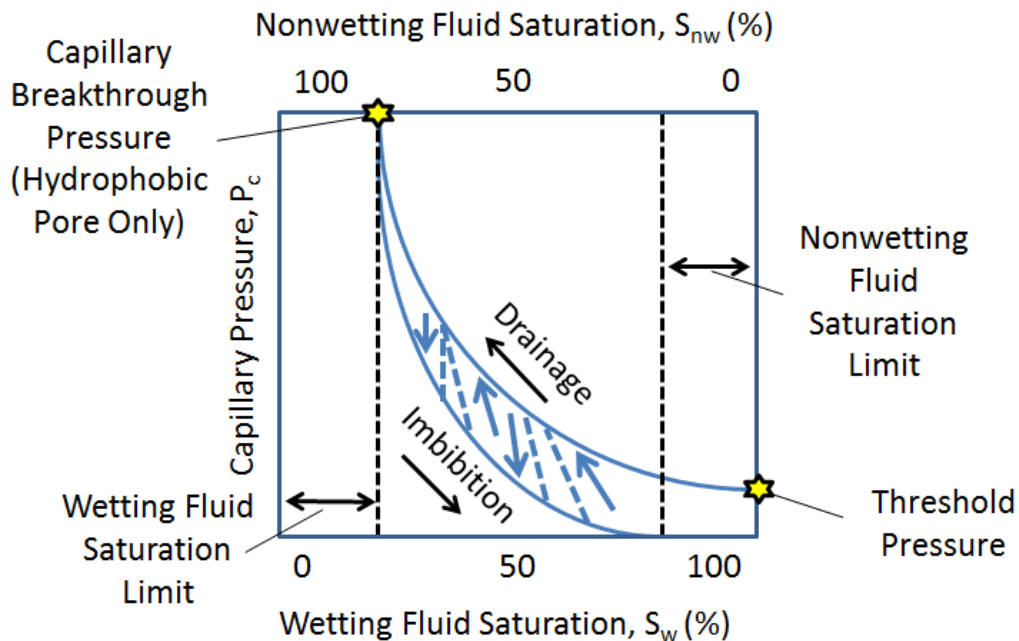
Figure 7: Capillary pressure versus wetting and nonwetting fluid saturation in a porous medium (Reproduced from [17]).

with respect to hydrophobic and hydrophilic pores is important in describing the capillary pressure driven flow through a GDL. The drainage and imbibition curves in Figure 7 show these relationships in a porous medium as well as the effect of hysteresis.

The hysteresis that is inherent to all GDLs causes the capillary pressure curves to differ based on whether the GDL is originally saturated with water or air in hydrophobic or hydrophilic regions [17]. The threshold pressure is the pressure of the nonwetting fluid that must be reached before drainage and displacement of the wetting fluid can be initiated. Capillary pressure rises as the saturation of the nonwetting fluid increases. Eventually a saturation limit is reached to which the capillary pressure cannot increase any further. Imbibition occurs when the nonwetting fluid displaces the wetting fluid. As imbibition occurs, the capillary pressure decreases along with the saturation of the nonwetting fluid. The nonwetting and wetting fluid saturation limits can change as drainage and imbibition reoccur due to the effect of hysteresis. The blue dotted lines and arrows in Figure 7 represent the hysteresis effect.

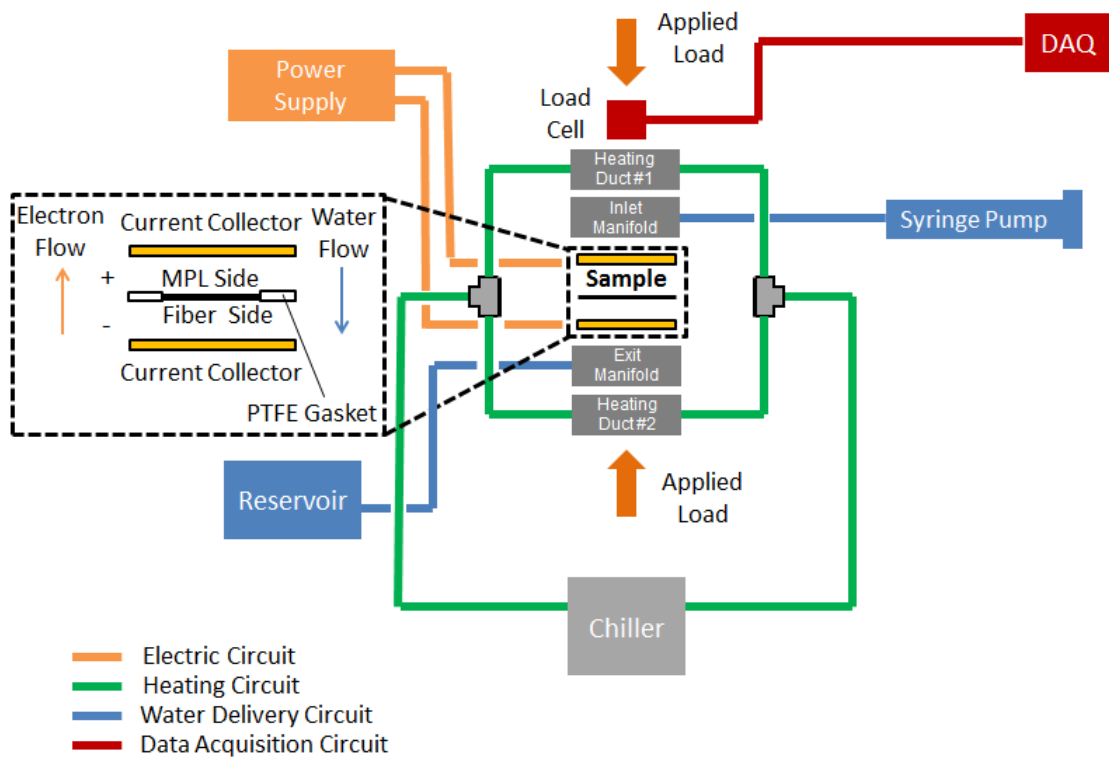
Figure 13: Schematic of the experimental setup.

Figure 13 shows a detailed schematic of the experimental setup and the various circuits that are required to simulate the PEMFC environment and acquire load and water pressure data.

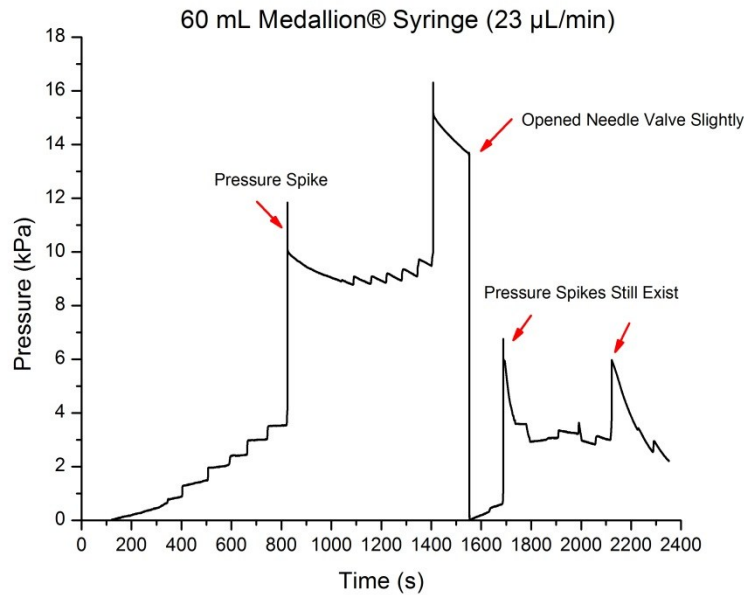
Figure 18: Pressure rise validation for 60 mL Medallion® syringe.

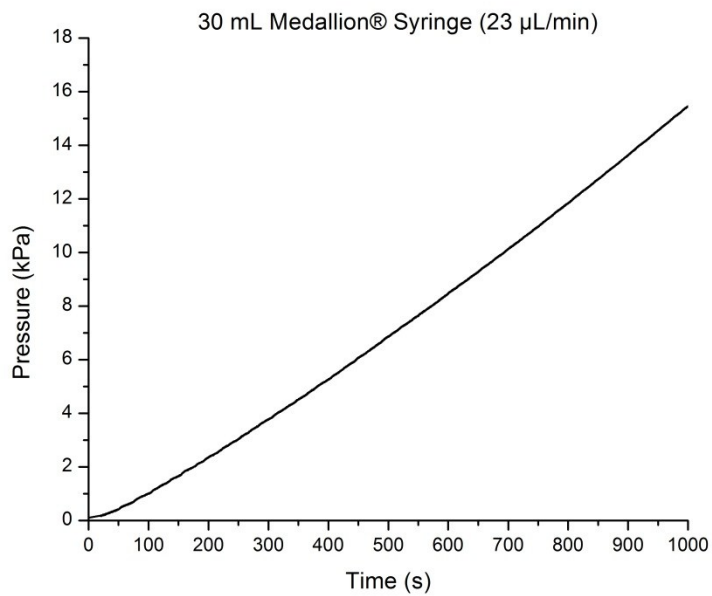
Figure 19: Pressure rise validation for 30 mL Medallion® syringe.

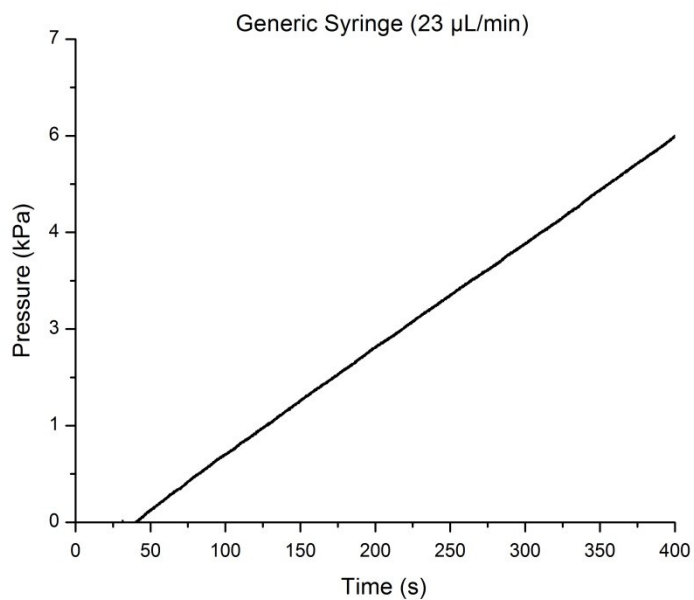
Figure 20: Pressure rise validation for generic syringe.

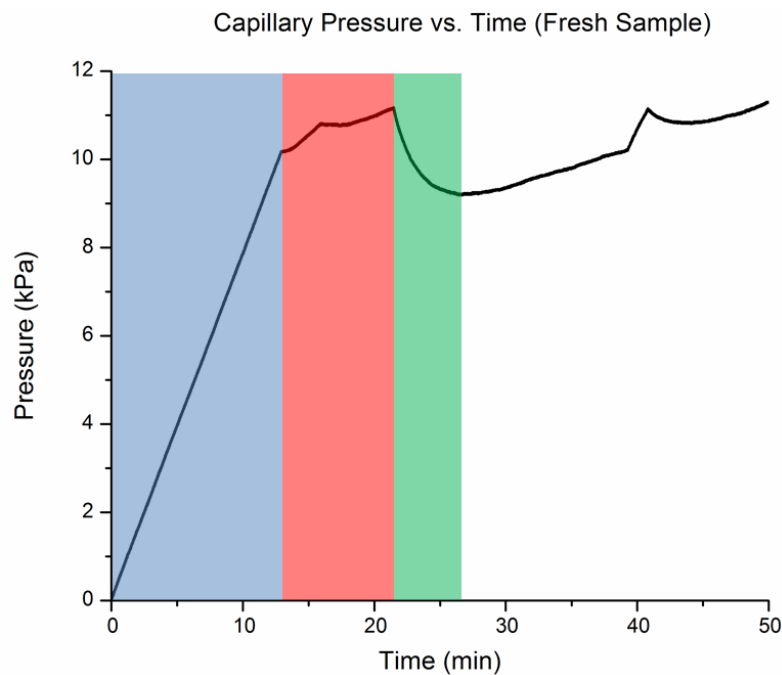
Figure 23: Water breakthrough behavior in the fresh GDL sample (1<sup>st</sup> test).

green region could be a CBP value and the green region could be an imbibition curve where air comes into the hydrophobic pores after water breakthrough. However, the time span of the red region is approximately 5.5 minutes. Given the area of the CCP water delivery channels, it would only take approximately 52 seconds to fill all of the GDL pores that were available directly adjacent to the water delivery channels. Even if the entire area of the CCP water delivery channel and land array is considered, the time only increases to about 1.6 minutes. This is still much less time than the 5.5 minutes shown in the red region and therefore the aforementioned claim cannot be made. Furthermore the time span of the green region is 5 minutes which is in stark contrast with the vertical drop in pressure after water breakthrough seen by Lu et al. [6] and the quick 1 minute drop offs seen by Liu et al. [23].

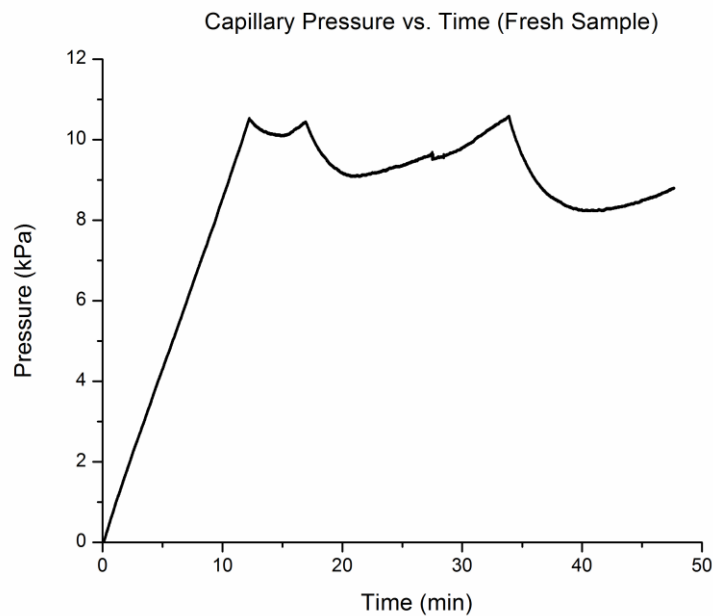
*Figure 24: Water breakthrough behavior in the fresh GDL sample (2<sup>nd</sup> test).*

Figure 24 shows the water breakthrough behavior during the second CBP measurement test. Water broke through and the pressure decreased immediately after which further supports the assumption that the threshold pressure is equal to the CBP value. The third test exhibited similar results as the first two.

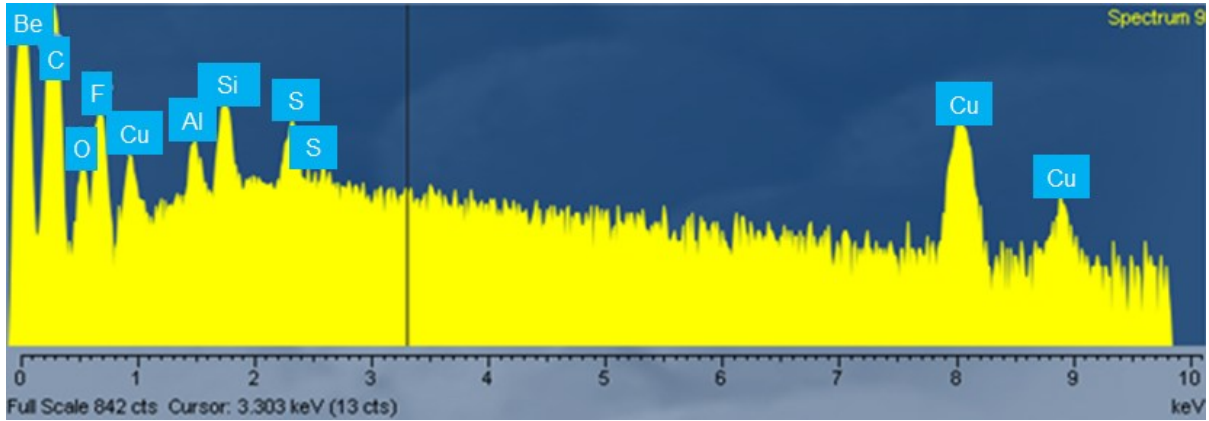
*Figure 44: Elemental concentration of the first material bridge on degraded S3 sample MPL surface.*

Figures 44 and 45 shows that additional elements were possibly present in the two material bridges. Table 14 outlines the elements that were picked up and the likelihood of them actually being present.

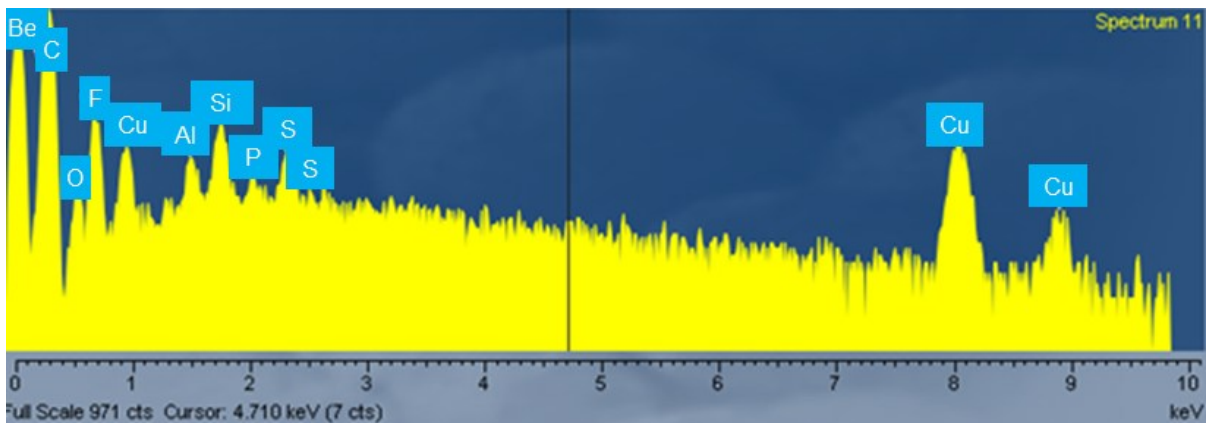
*Figure 45: Elemental concentration of the second material bridge on degraded S3 sample MPL surface.*
