### The Effects of high vibration on the steam turbo-generator machine of the unit B1 339 MW in thermal power plant "Kosovo B" : [presented August 2009]

## **The Effects of High Vibration on the Steam Turbo-Generator Machine of the Unit B1 339 MW in Thermal Power Plant “Kosovo B”**

Prepared by: Jonuz Saraçi  
August, 2009

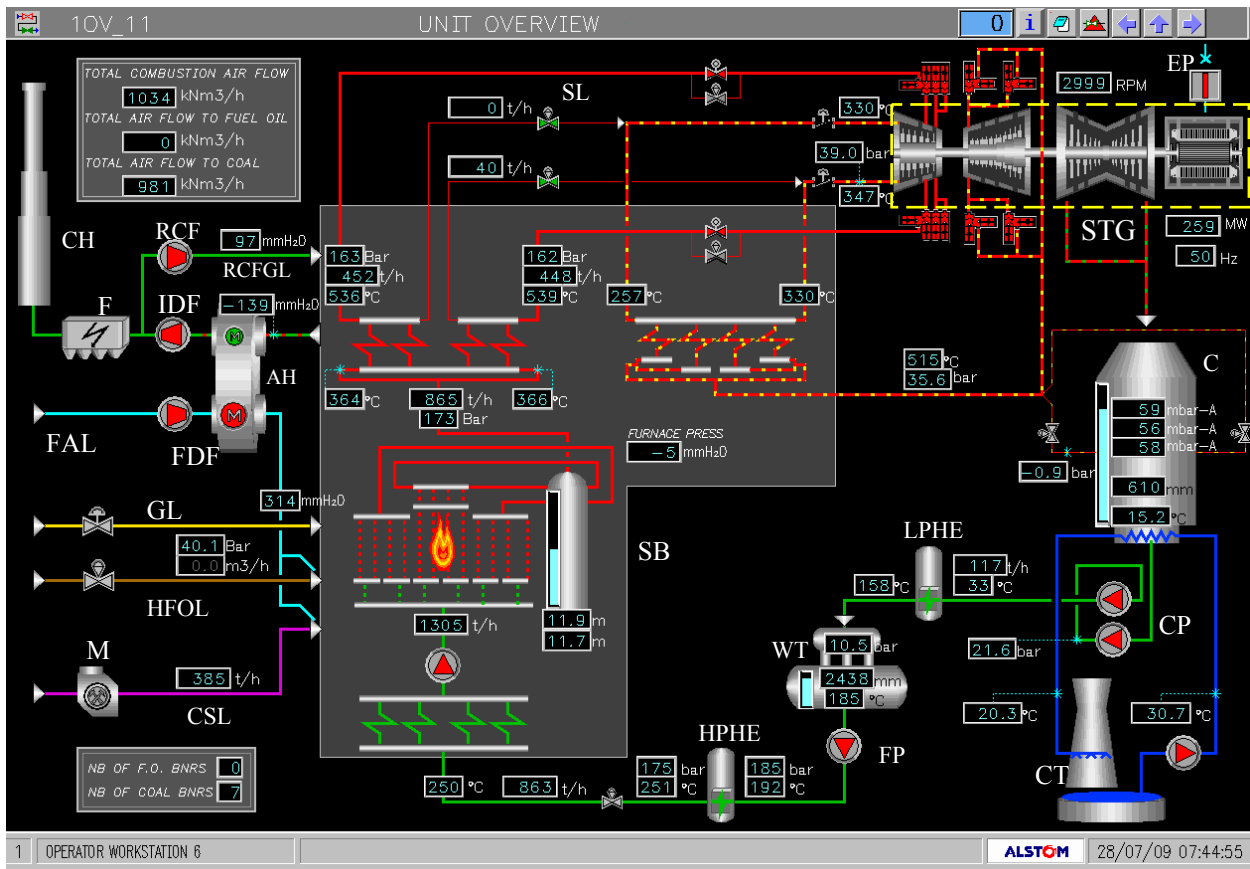
Figure 1: The scheme of TPP “Kosovo B” Unit B1 with operational parameters for capacity 259 MW

The Steam Turbo-Generator machine STG (**Figure 1**) was installed in 1983 as part of the unit B1 339 MW in TPP “Kosovo B” and is one of the most important machines for generating electricity. This machine is the heart of unit B1, therefore, to monitor its condition during start up, normal operation and shut downs, a new sophisticated **on-line** monitoring vibration system called VIBROMETER **VM600** was installed 2003. This system permanently monitors the relative shaft vibration up to the 10<sup>th</sup> (tenth) journal bearing of the STG-B1 machine. Each bearing is fitted with 2 relative shaft vibration sensors (one in the vertical direction Y and the other in horizontal X (Figure 2)).

As shown in Figure 1, the STG-B1 machine is directly connected to the production of electricity and unplanned shut downs can have catastrophic consequences for the unit. We should also take into consideration that if the STG-B1 machine stops running for any problem, there will be a loss of approximately 260 MW electrical power per hour. On the other hand, depending on the problems that may be present, this machine may require expensive repairs over a long period of time.

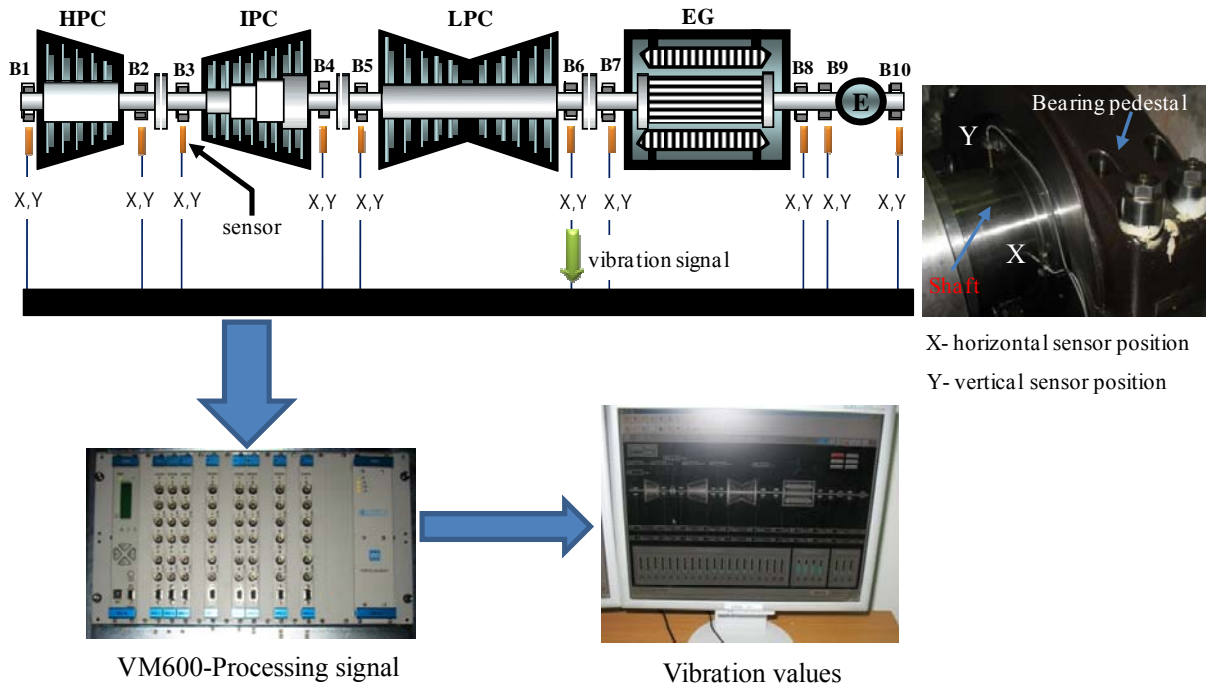
Figure 2: The on-line monitoring vibration system VM600 in the STG-B1 machine

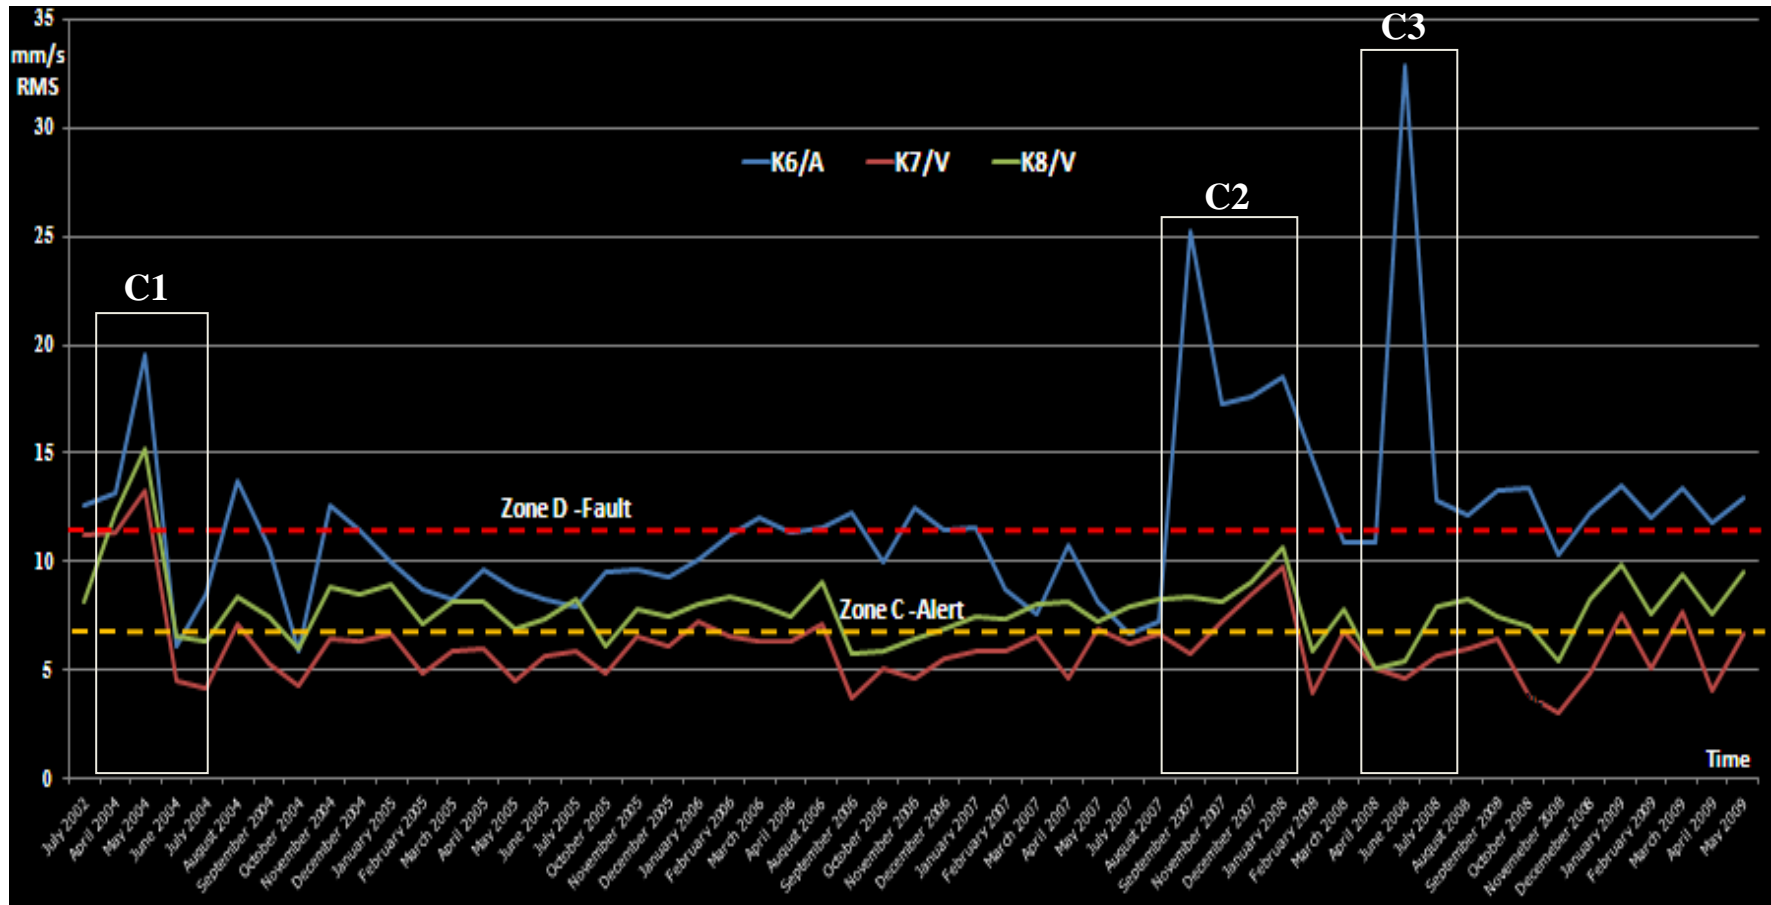
Figure 3: The trend of vibration measurement points B6/A, B7/V and B8/V for 5 years of the machine operation

C1- the event when a balancing generator rotor was done (vibrations are decreased)

C2 and C3 – the events when the blades of Low Pressure Rotor (LPR) in stage 27A and 29A were cracked (see Fig. 8)

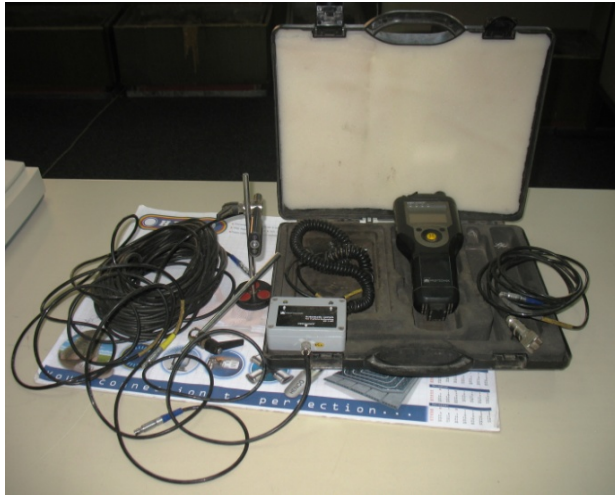
1. **VIBSCANNER** – an off-line instrument with two channels for measuring and collecting the absolute vibration data on the bearing pedestals (Figure 11a). This type of transducer is an accelerometer with a frequency range of 2Hz - 20 kHz.

Fig. 11a: VIBSCANNER instrument

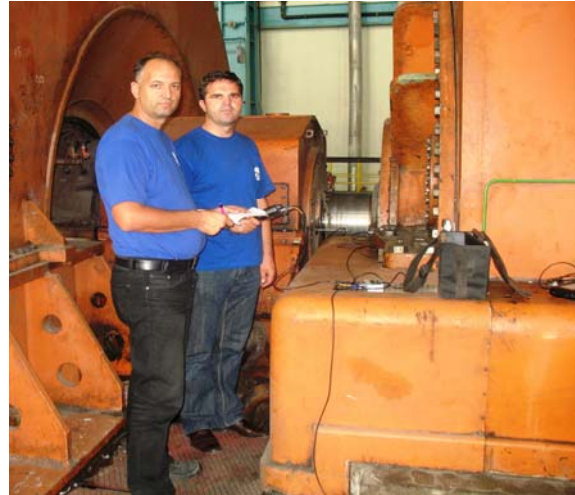
Fig. 11b: Collecting vibration data with VIBSCANNER

The work of collecting vibration data with the VIBSCANNER instrument began with putting reflective tape on the shaft (Figure 16) before the start run of the machine because it was necessary to read the phase and analyze vibration. The other activity was putting all accessories of the VIBSANNER instrument on the machine Figure 11b.

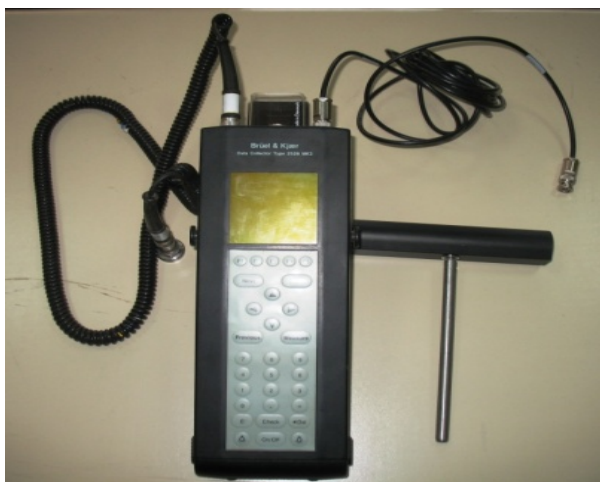
4. **BRUEL & KJEAR Data collector 2526** (Figure 15a) - I used this instrument to receive signals from the on-line monitoring vibration system, VM600, and processing them in the FFT vibration spectrum because in this instrument a channel is installed for connection to on-line monitoring vibration system (VM600) Figure 15b.

Fig. 15a: Bruel & Kjar 2526 instrument

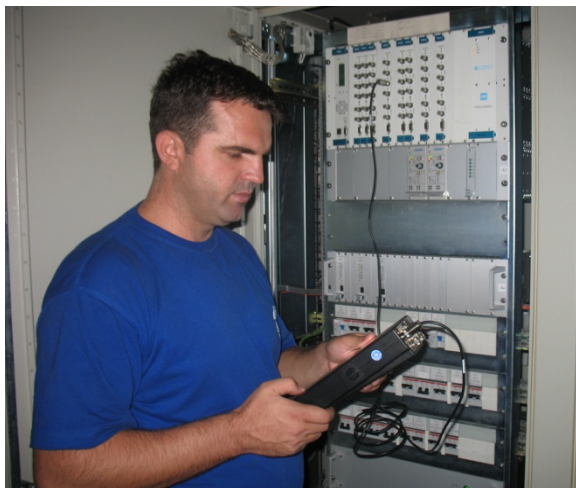
Fig. 15b: Collecting shaft vibration data with Bruel & Kjar instrument

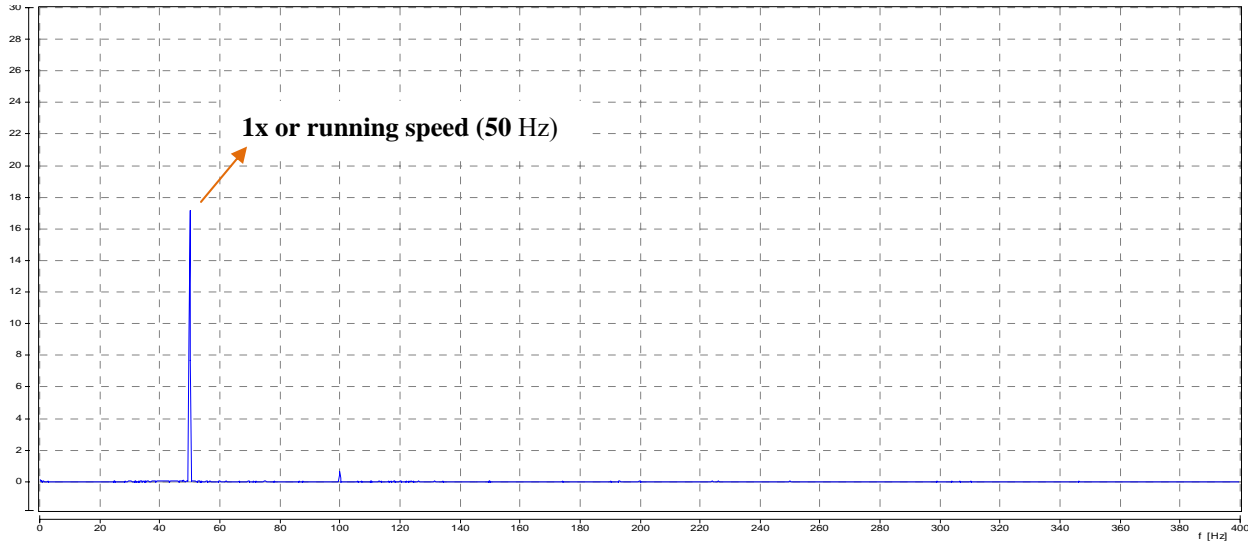
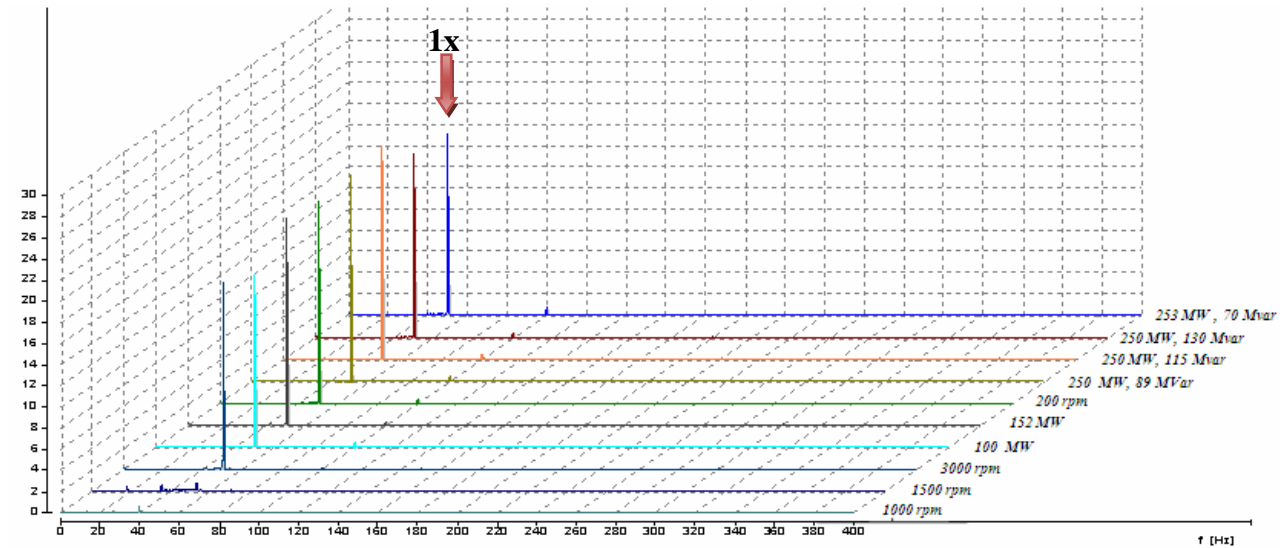
Figure 17a- The waveform spectrum collected from B6/A vibration signal (250 MW)

Figure 17b: The FFT spectrum collected from B6/A vibration signal (250 MW)

Figure 17c- The cascade FFT spectrum collected from B6/A vibration signal for different loads

The vibrations on the bearing B6/A have the same symptoms as on the bearing B7/V and B8/V. From the FFT spectrum taken on the B6/A vibration signal we can identify that the high amplitude vibration is one per revolution or 50 Hz (Figure 17b). The difference is that the high vibration value on the bearing B6 is in the axial direction, which indicates another source of vibration problem. The books “Machinery vibration-Alignment” written by Victor Wowk and “The Vibration Analysis Handbook” written by James L. Trylor also emphasize that if the axial vibrations are high in 1x, or once per revolution, the problem of increased axial vibration should be angular misalignment (Figure 27). The angular shaft misalignment is said to occur when the centerlines of rotation of two machine shafts are supposed to be collinear but are not in line with each other.

7. The cause of the increase vibrations in the B6/A is due to the shaft misalignment between the LP rotor and generator rotor, and the high vibration level in the Electrical Generator.

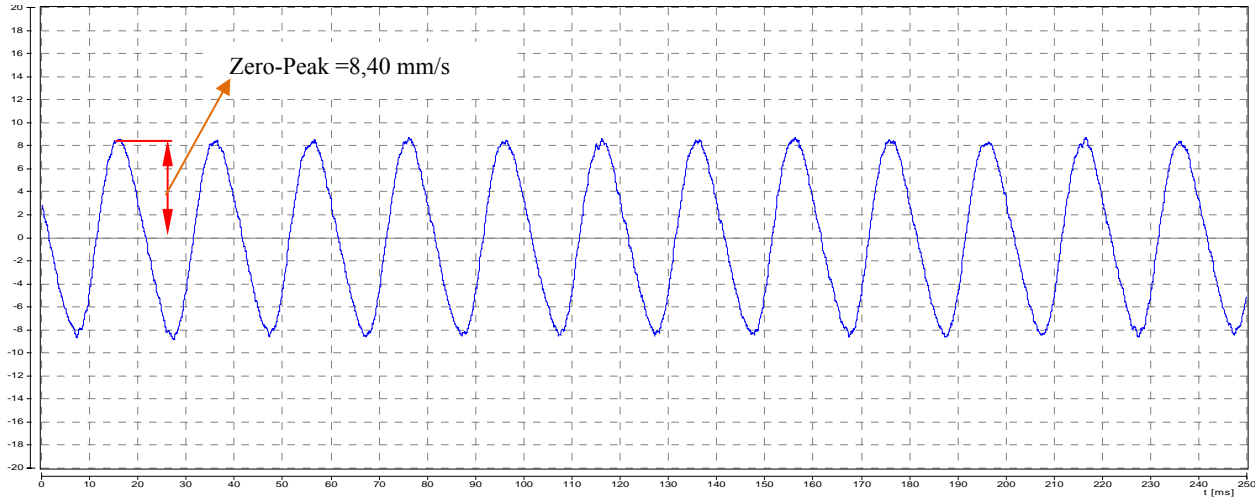
Figure 18a: The waveform spectrum collected from B7/V vibration signal (250 MW)

Figure 18b: The FFT spectrum collected from B7/V vibration signal (250 MW)

Figure 18c- The cascade FFT spectrum collected from B7/V vibration signal for different loads

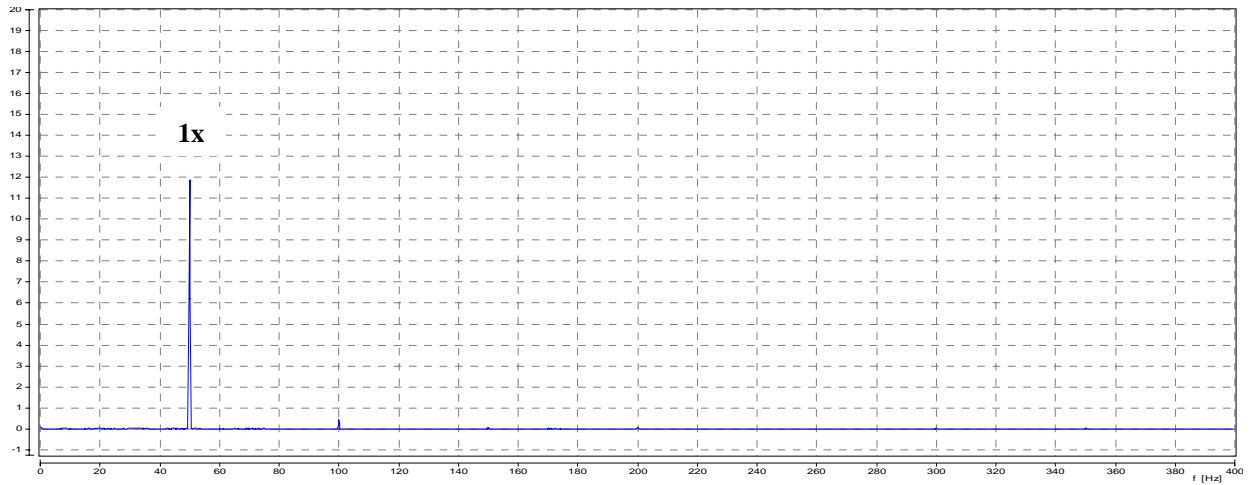
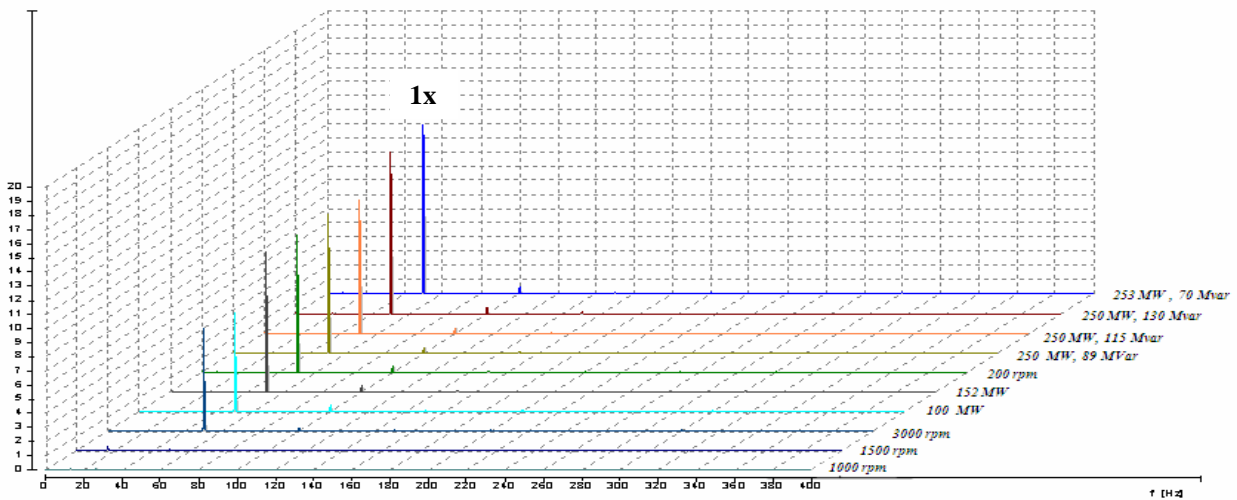
Figure 19a- The waveform spectrum collected from B8/V vibration signal (250 MW)

Figure 19b: The FFT spectrum collected from B8/V vibration signal (250 MW)

Figure 19c- The cascade FFT spectrum collected from B8/V vibration signal for different loads

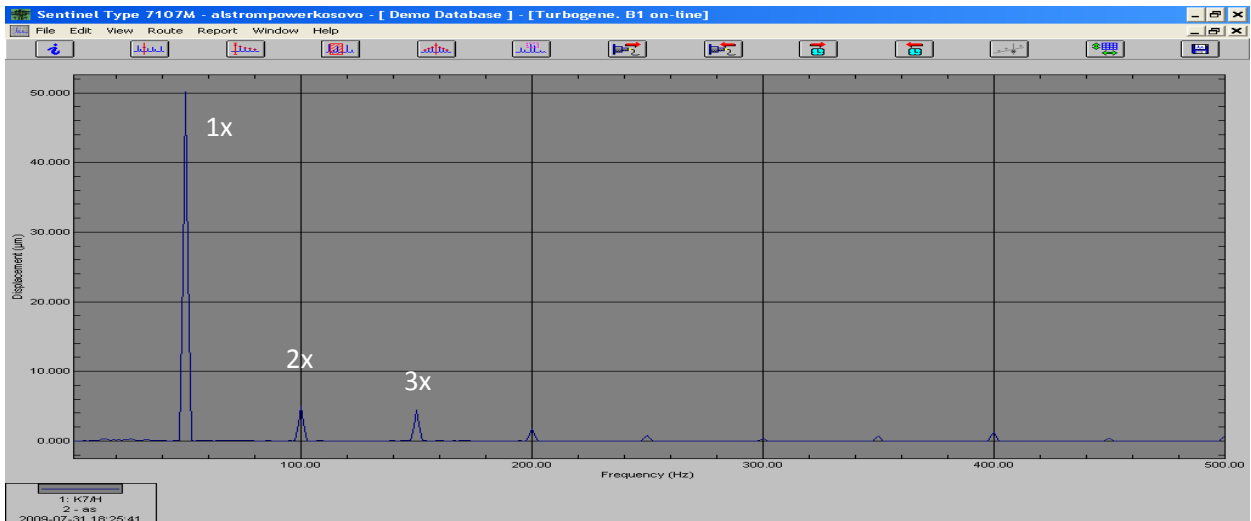
Fig. 21a: The FFT spectrum taken from B7/H vibration signal

Fig. 21b: The FFT spectrum taken from B7/V vibration signal

As shown in Table 6 and from the FFT spectrums collected, the relative shaft vibration results didn't show any critical value as much as absolute vibration measurements but indicated the same nature of vibration problems. The relative shaft vibration measurements on the bearing B7 and B8 changed when the reactive power was 115 and 130 MVar (Figure 22, on-line monitoring vibration system VM600).

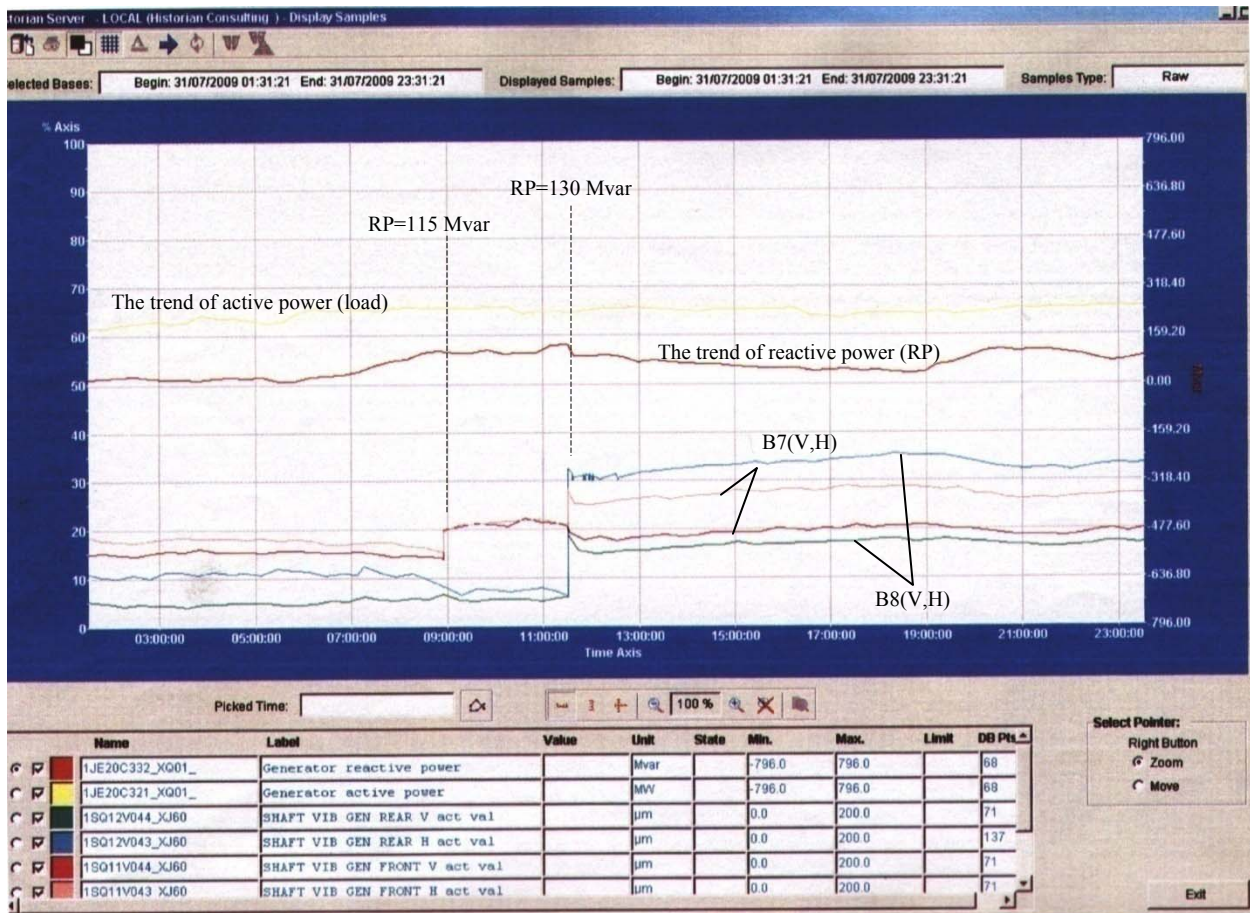
Figure 22: The trends of active and reactive powers, and relative shaft vibration measurements of the two support bearings of electrical generator (B7/V, H and B8/V, H), taken from the TPP “Kosovo B” unit B1 control room

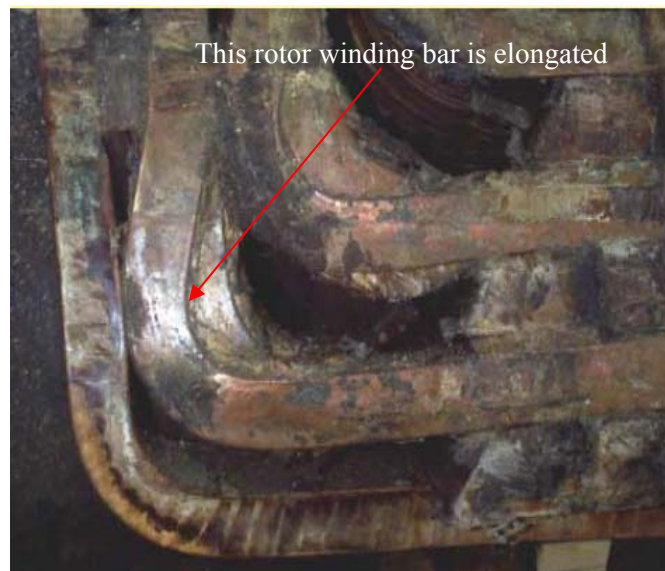
The only dynamic generator rotor unbalance isn't the main problem of increase vibration in the electrical generator. During our test of how the amplitude vibration changes if the reactive power is increased for the same load (this phenomenon caused heating up the generator rotor), the relative shaft vibration on the electrical generator changes (Figure 22). When the reactive power was increased to 115 MVar, the amplitude of shaft vibration on the measurement points B7/V, B7/H was increased, while the vibration on the B8/H was decreased (B8/V-constant). By increasing the reactive power to 130 Mvar, again the shaft vibration changed. Now the amplitude of vibration on the measurement points B8/V, B8/H and B7/H increased, while the amplitude vibration on the B7/V was approximately constant. With this phenomenon, we could conclude that the vibrations on the electrical generator depend on the reactive power. This is a symptom of **thermal rotor instability**. Some of the rotor winding bars are elongated when the rotor is heating up and after the cooling process the vibrations do not return to the same position (an example is shown in Fig. 26). To return the amplitude vibrations to the previous value one needs to increase the reactive power to 155 MVar (see appendix B, Fig. 33).

Fig. 26: An example, when Generator Rotor winding bars are elongated

3. The generator rotor winding bars should be repaired because the results of the vibration analysis measurements indicated this is a problem.
4. For the long-term of the STG-B1 machine operation, a general generator rotor repair is necessary (rotor winding bars repair and balancing).

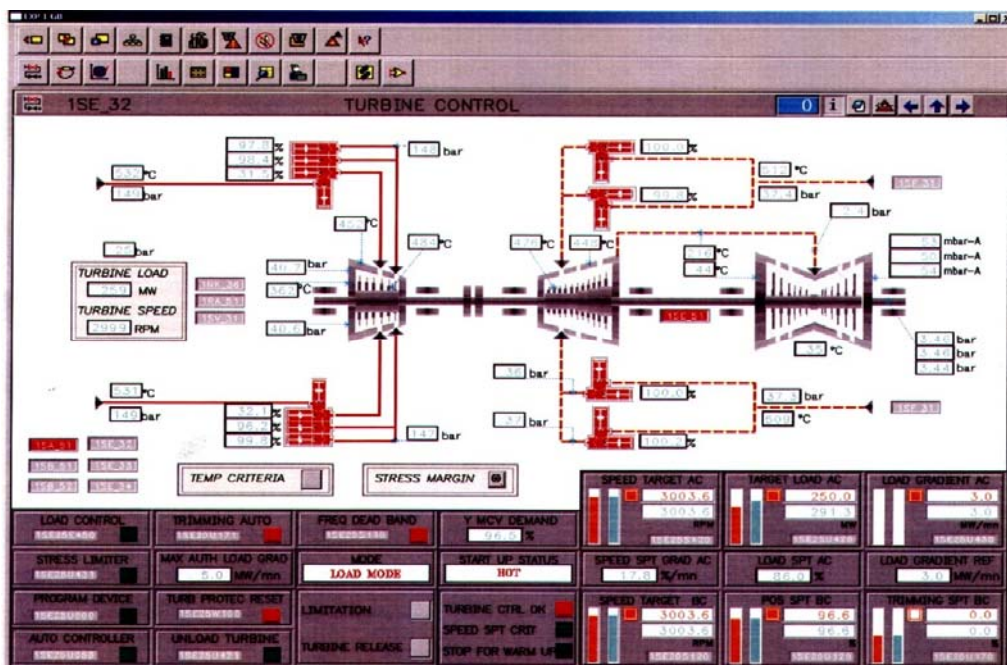
Fig. 30: The scheme of turbine control
