PLASMA DAMAGE TO NMOS CAPACITORS

Matthew J. Strong
5th Year Microelectronic Engineering Student
Rochester Institute of Technology

ABSTRACT

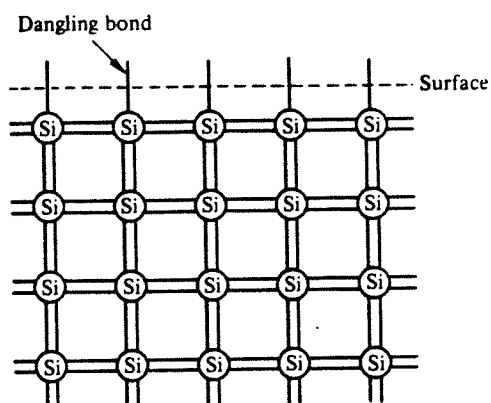
Figure 1 Physical model for the interfacial traps caused by the abrupt termination of the Si lattice. [5]

In any thermally grown oxide there are electrically active traps at the Si-SiO₂ interface. These interface traps result from dangling bonds. These dangling bonds are caused by the abrupt ending of a silicon lattice or impurities in the oxide [4,5]. Figure 1 illustrates the physical model of a dangling bond.

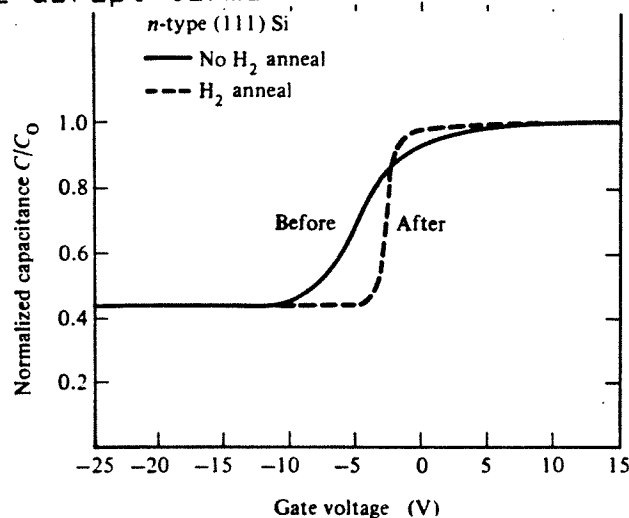
Figure 2 Ideal C-V curves vs plasma damaged C-V curves.

damages the oxide will be determined by examining the high frequency C-V curves of NMOS capacitors. The first step in the project is the fabrication of these NMOS capacitors. From the C-V curves, the flatband and the threshold voltages will be examined for shifts, as well as general slope vs theory curves. Figure 2 shows an ideal C-V curve vs a plasma damaged C-V curve. This experiment will attempt to match these curves.

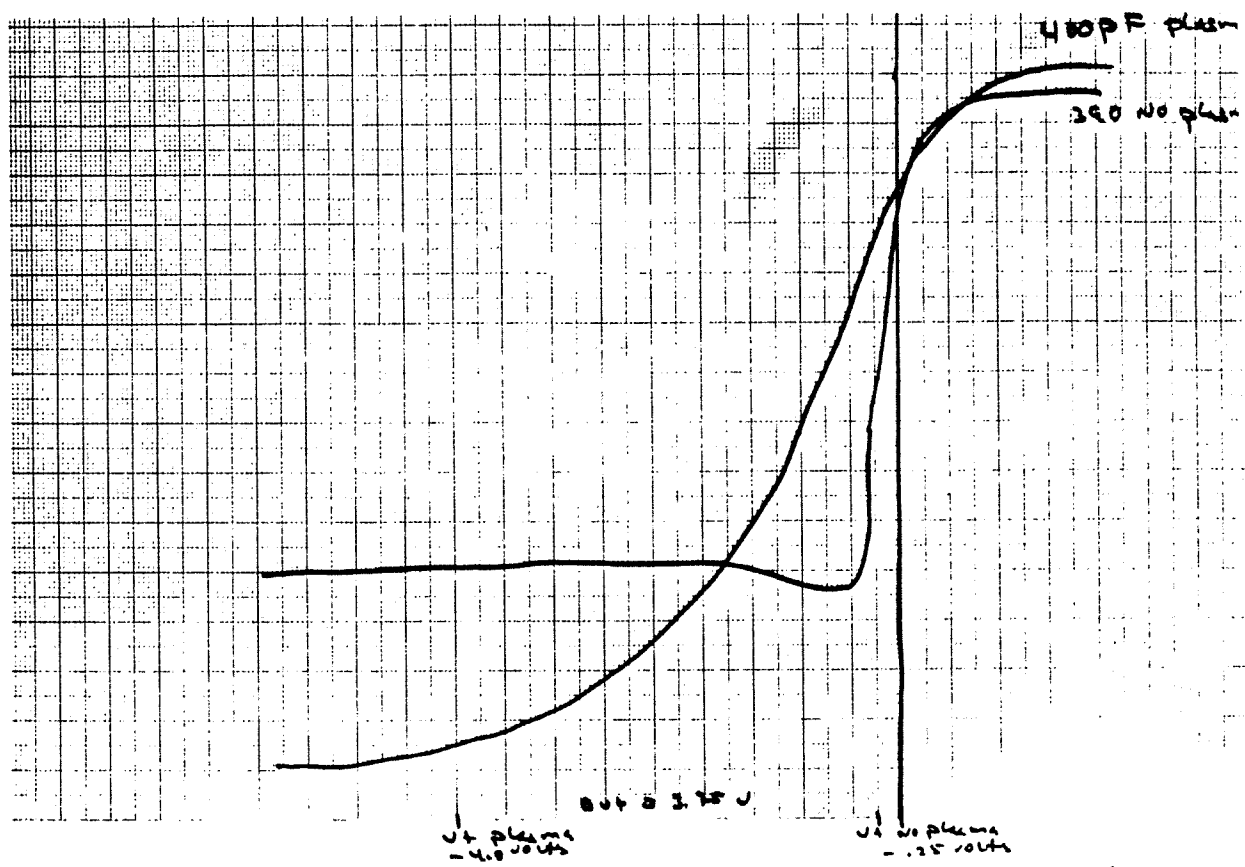
Figure 3: Capacitance Voltage Curves with and without Plasma for the 450A oxide.

Figure 3 and Figure 4 are typical C-V plots. These C-V plots have both the damaged and undamaged capacitors shown. As can be seen the oxides that saw the plasma suffer degradation. The C-V plots show a shift in both the threshold and the flatband voltage as well as a change in slope. The gradual slope of the damaged oxides indicates more interfaces sites than the undamaged oxides. The thinner oxide shows the greater shift in the C-V curves.

For an oxide of 450A the delta V_t shift was found to be -1.50 volts with a deviation of 1.16.

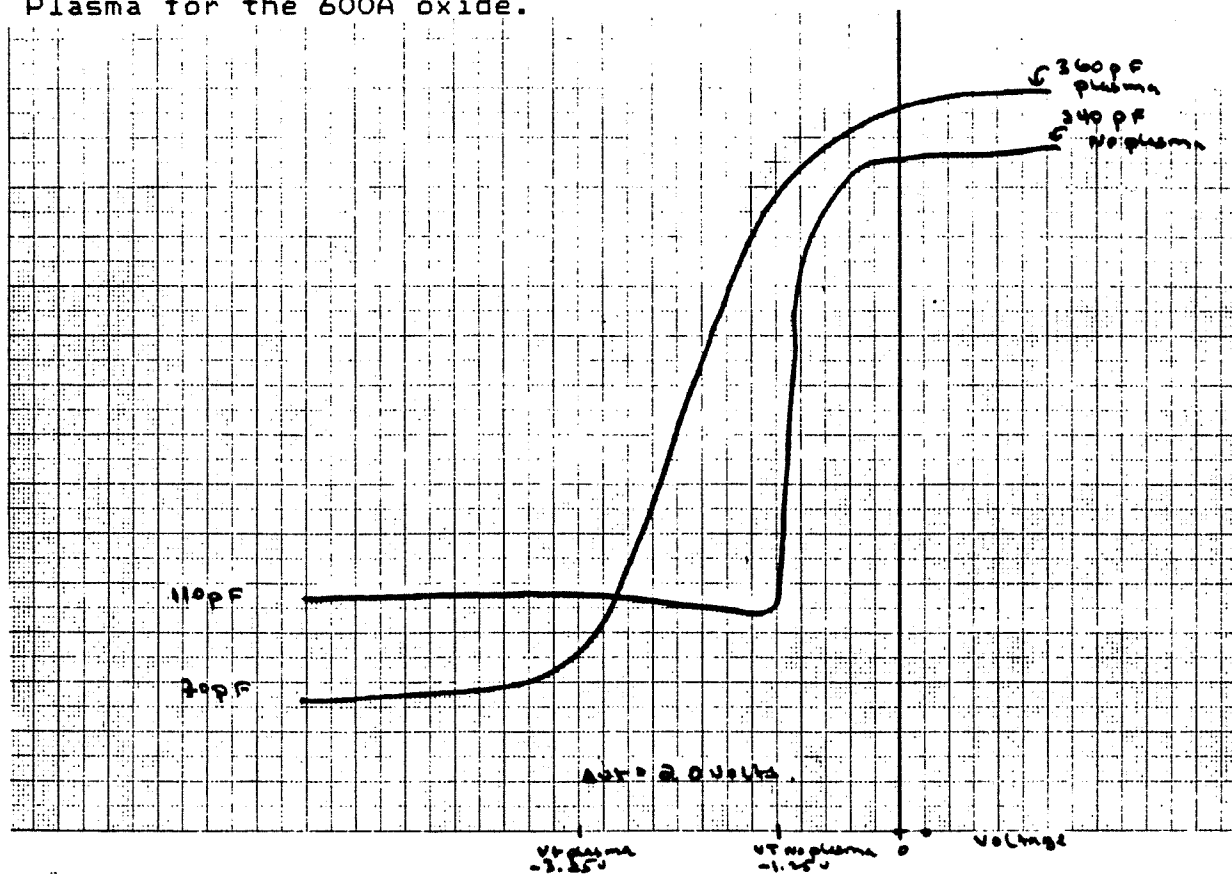
Figure 4: Capacitance Voltage Curves with and without Plasma for the 600A oxide.

For an oxide of 600A the delta Vfb shift was found to be - 1.10V with a deviation of 0.35.

From the table the thinner oxide was more noticeably affected by the plasma damage. The thinner oxides flatband voltage was shifted by -2.17V, whereas the thicker oxides flatband voltage was shifted by only -1.68V. The tables indicate that Cox and Cmin were also affected. The Cmin of the plasma damaged capacitors were less capacitive. The Cox however became more capacitive in the plasma damaged cases. The thinner oxide showed the greater affects of the plasma damage.
